## DVASE 2019 Excellence in Structural Engineering Awards Program

| Name of Project: | <b>222 Rittenhouse</b> |
| Location of Project: | <b>222 West Rittenhouse Square, Philadelphia, PA</b> |

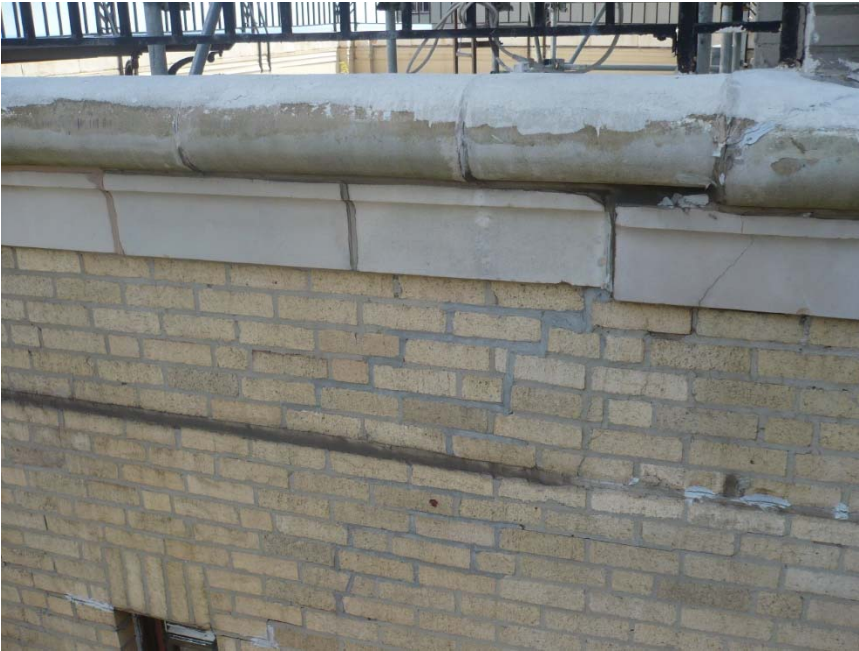
As the design professional gained additional access to the building, more issues were revealed, and trends were tracked across the façades. It became evident that the building was not as well maintained as was previously thought, and poorly-executed repairs were causing damage to the building. Specifically, joints within the terra cotta band stone and along the steel floor plate above the spandrel beams were caulked shut, trapping water beneath the surface causing corrosion. This phenomenon repeated throughout the façade, with corrosion jacking at the balconies, parapets, and spandrel beams; requiring brick reconstruction and steel reinforcement.

Figure 4: Caulk along spandrel beam mortar joint, brick and terra cotta cracking, parapet jacking.

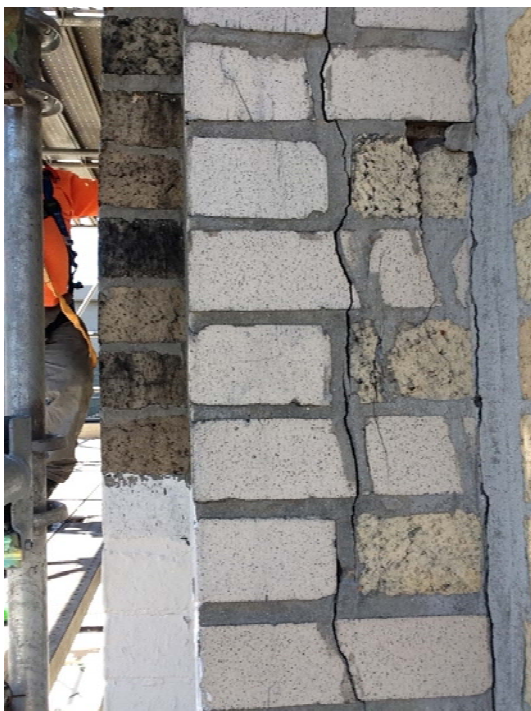
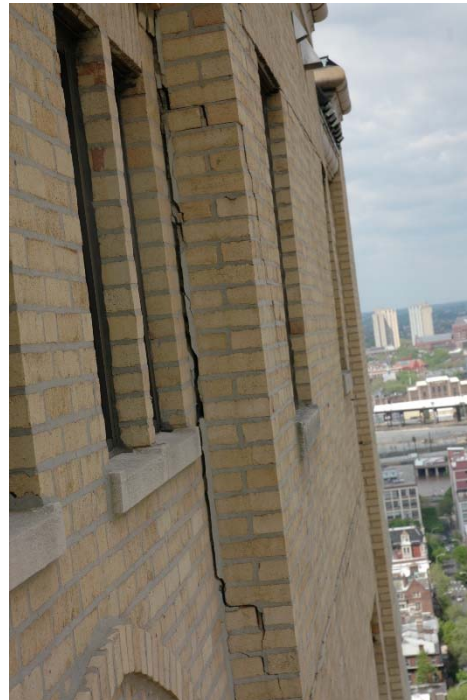
Figure 5 & 6: Cracking at building corners and between panel setbacks.

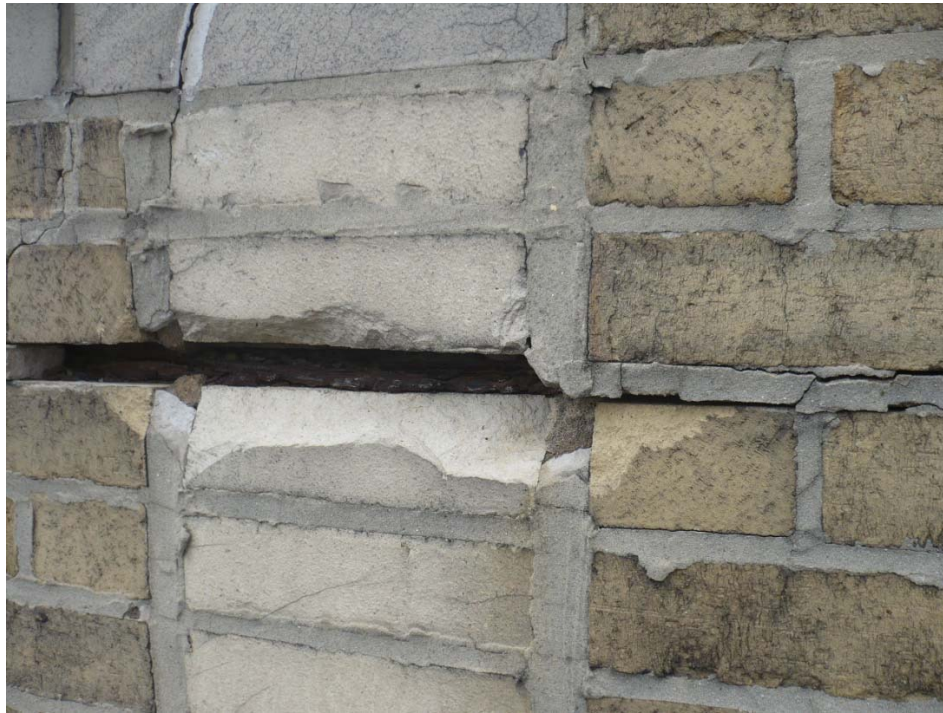
Figure 7: Corrosion jacking at spandrel joint and brick spalling.

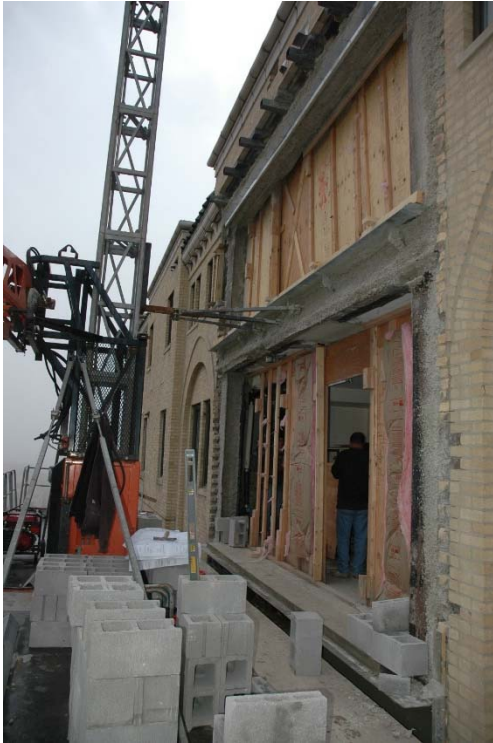
Major cracking was discovered at the 27<sup>th</sup> floor, and steeplejacks were used to repel down the façade to install temporary shoring. The design team developed details to install an interior counterweight system to support the roof cornice so that the entire unstable area, a two-story masonry panel, could be removed and replaced. Another significant issue was observed at the south elevation parapet. From the coping stones continuing downward to the attic floor level, the parapet was found to be bowing and bellied outward. The wall was stabilized by installing CMU pilasters inside the attic with a series of threaded rods and galvanized plates to securely brace the wall. The brick was rebuilt between the bottom of the window lintel at the attic level to the bottom of the terra cotta coping stone of the parapet. This proved to be an effective solution without having to remove and reconstruct the entire wall which would have threatened the valuable, newly replaced elevator machinery, located just inside this wall, just inches away from the instability.

Figure 9: Reconstruction of the top two wall panels below the roof cornice.

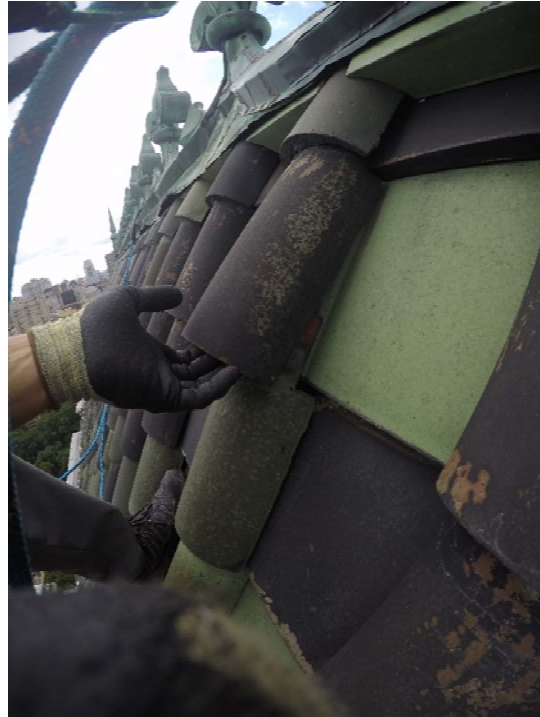
The most notable condition of this façade inspection was the condition of the terra cotta tile roof. With such a high level of difficulty to obtain access for the needed inspection, a specialized crew, consisting of professional vertical access rope technicians, were able to conduct a hands-on inspection. Over thirty loose tiles were removed from the roof and a temporary roofing membrane was applied at the location of missing tiles. Since the budget for Phase 2 concentrated on the façade restoration, there was little left for a roof replacement. The missing roof tiles were replaced and temporary roof netting was installed so that a full replacement could be planned for in the next phase.

Figure 10: Detached roof tiles.
