## DVASE 2019 Excellence in Structural Engineering Awards Program

| Name of Project: | Restoration of Nassau Hall Cupola, Nassau Hall, Princeton University |

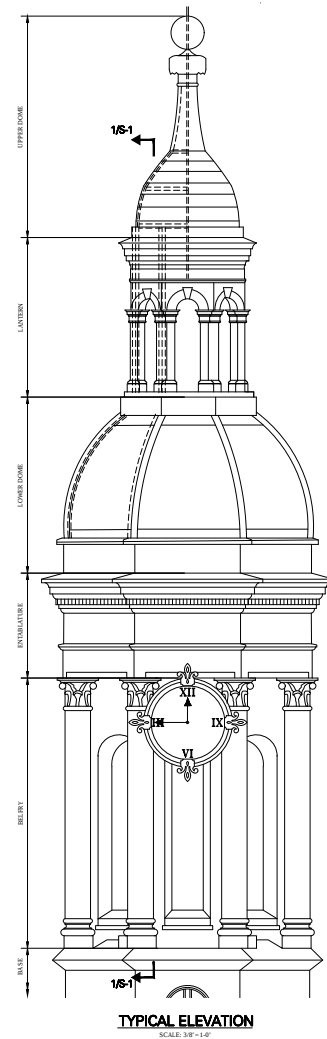
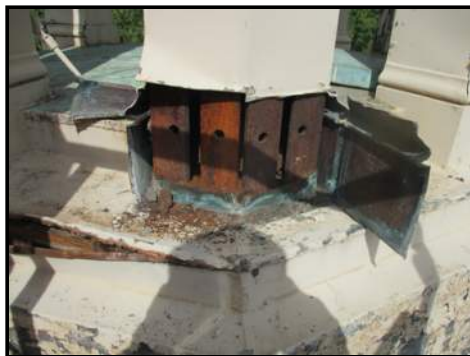
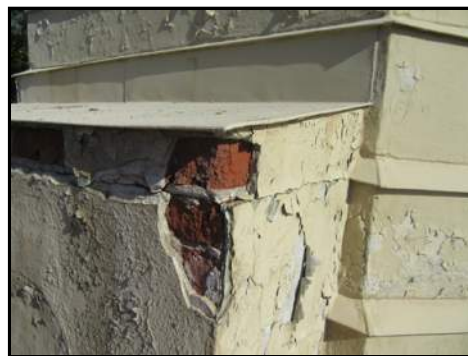
Existing conditions at time of survey - corroded iron framing elements at lantern columns; delaminated stucco and spalled brick masonry at base.

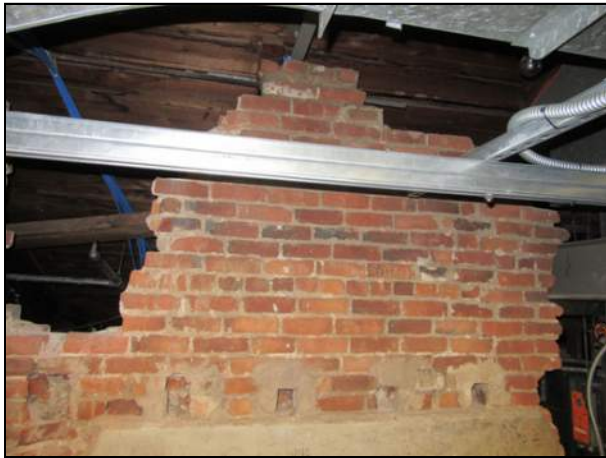
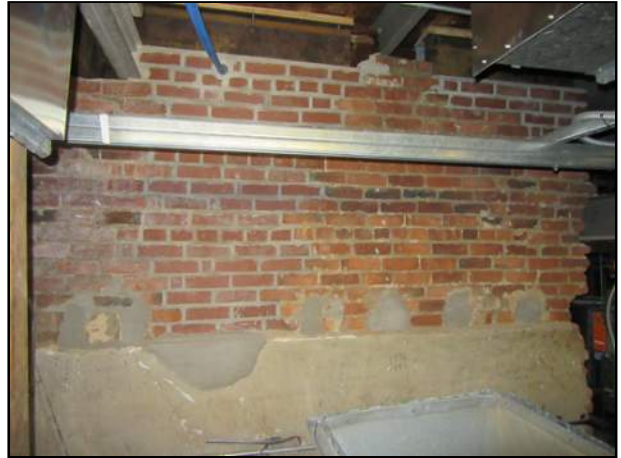
Before and after - bearing wall improvements in attic to support scaffolding loads.

A challenge of the project was the access. The most effective way to access the bell tower and maintain building operations was to install pipe scaffolding above the roof. Due to the building configuration, the scaffolding was designed to be supported by the interior load bearing masonry walls below the roof structure. We analyzed the roof framing and identify load bearing walls that could resist the scaffolding loads. However, the integrity of these load bearing walls to resist these imposed construction loads was compromised due to previous mechanical system alterations. We provided repair details to rebuild and strengthen the walls to safely resist the imposed scaffolding loads.

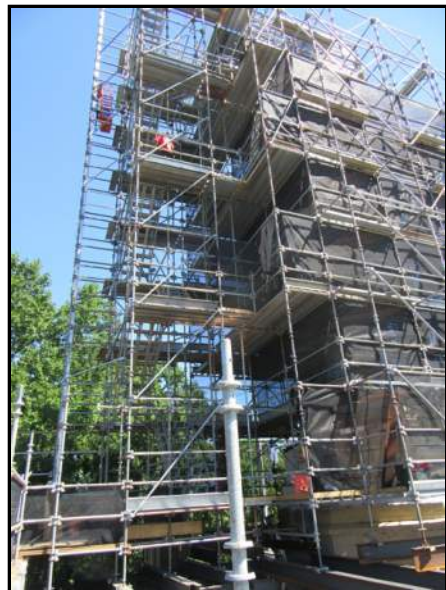
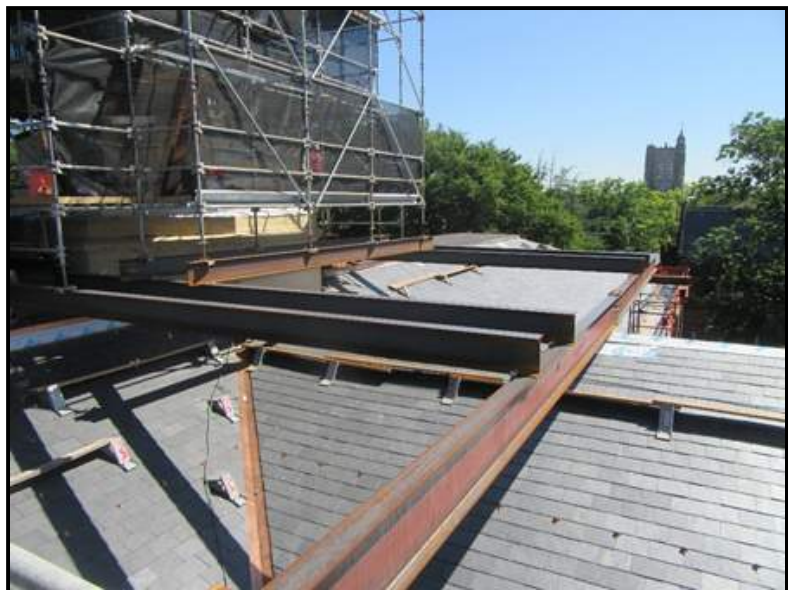
Bell tower scaffolding bridging main roof.

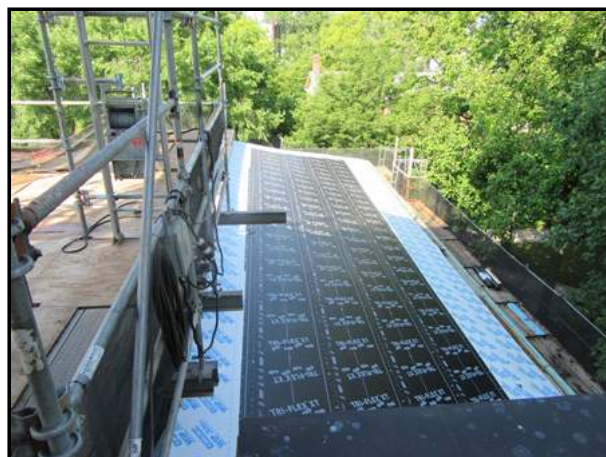
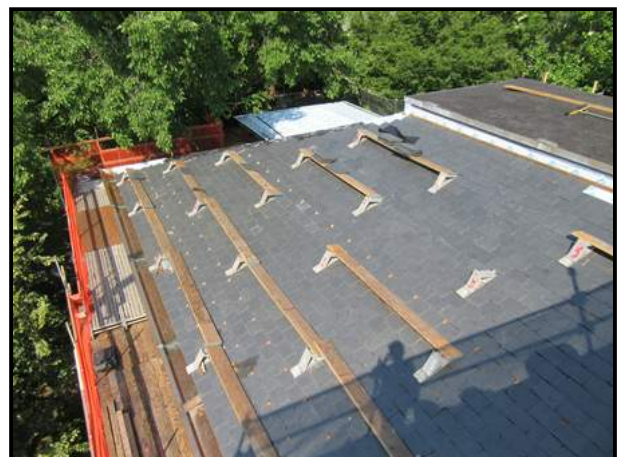
Roof replacement in progress.

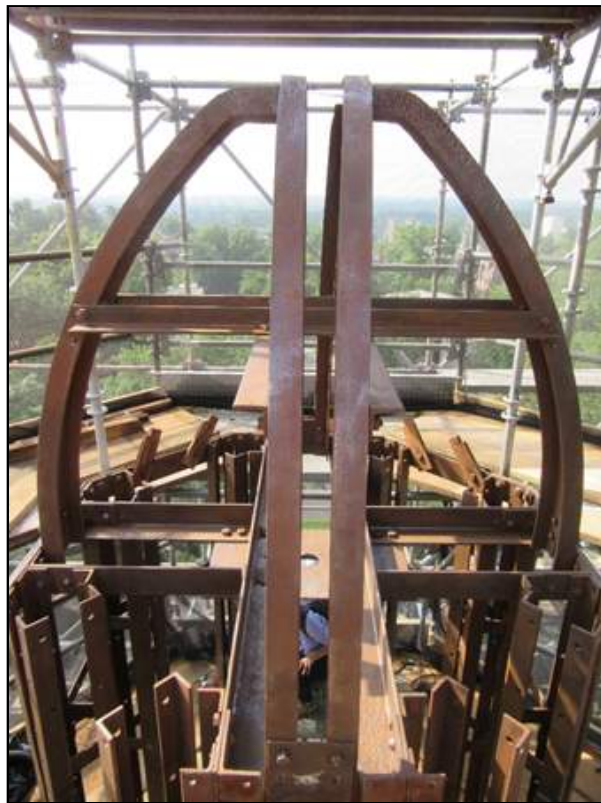
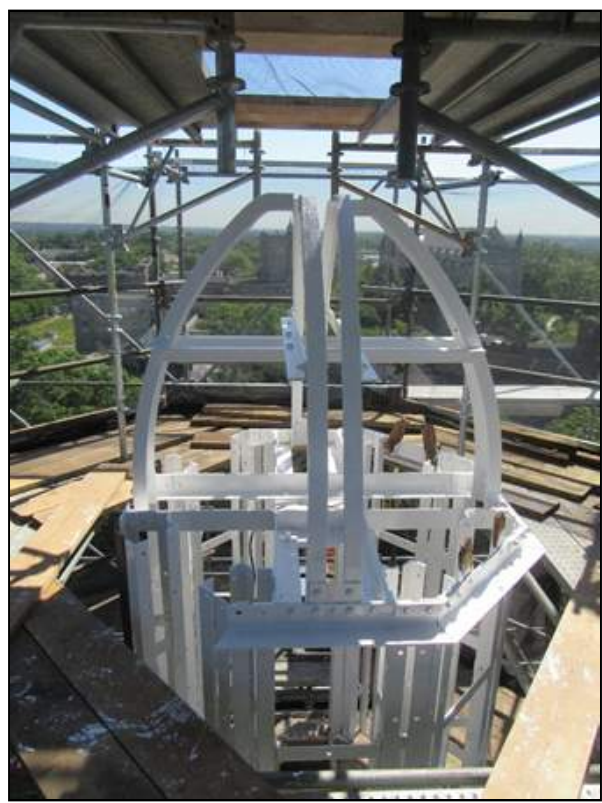
Iron frame rehabilitation in progress.

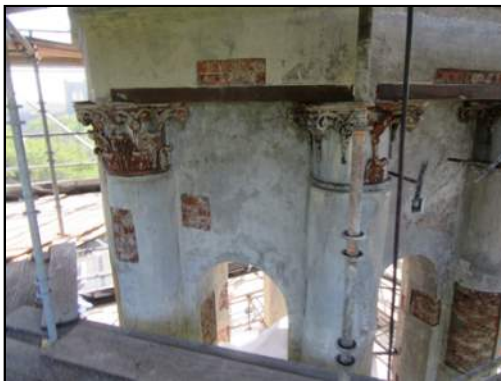
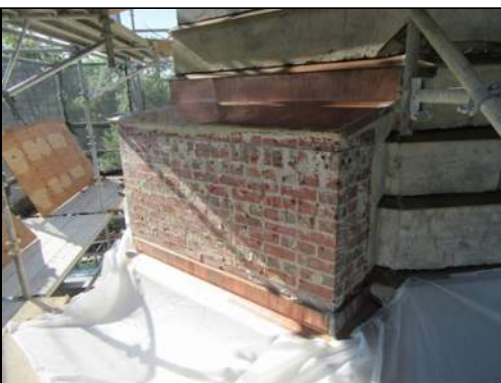
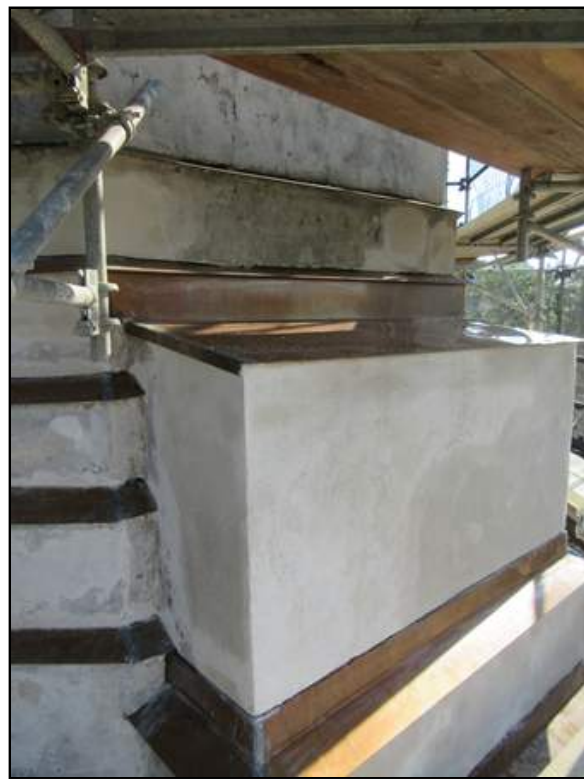
Brick masonry and stucco repairs in progress.

All masonry elements of the tower were repaired as well. All stucco surfaces were sounded, delaminated material removed and replaced. Cracked, spalled brick masonry was rebuilt. A protective coating was applied to all masonry surfaces.

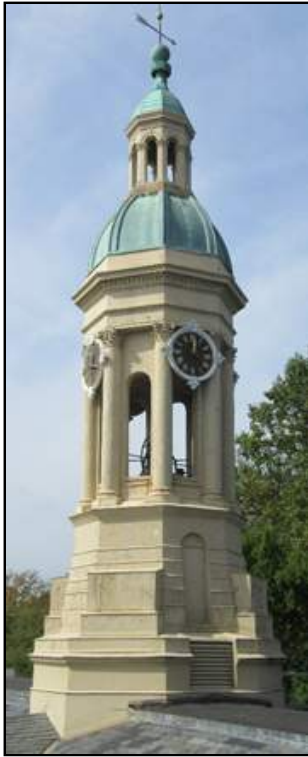
Before.

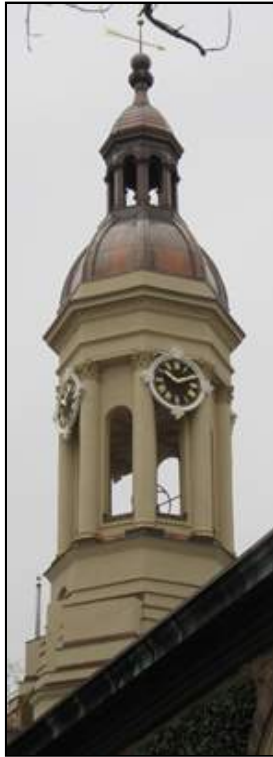
Completed.

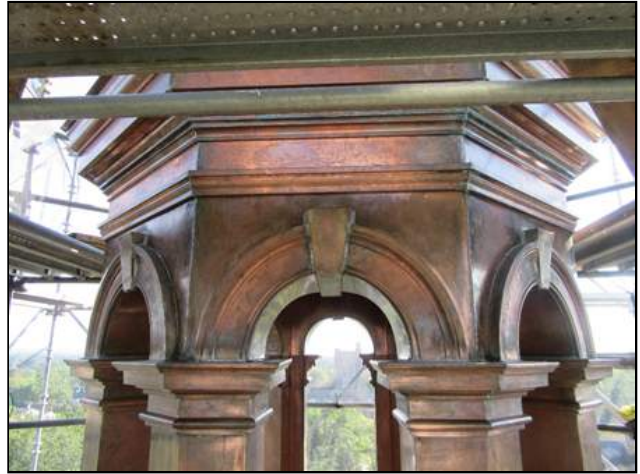
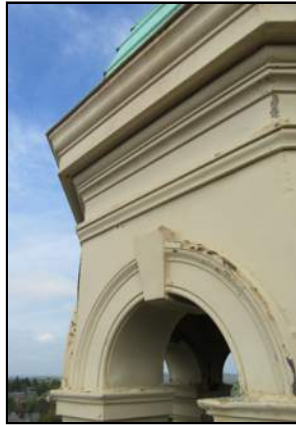
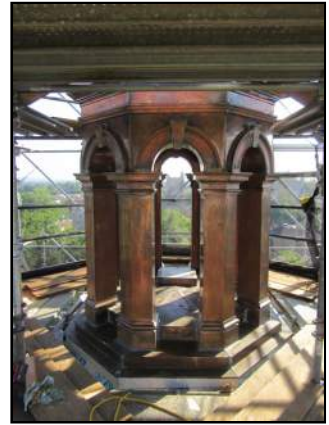
New copper cladding installed to match original.

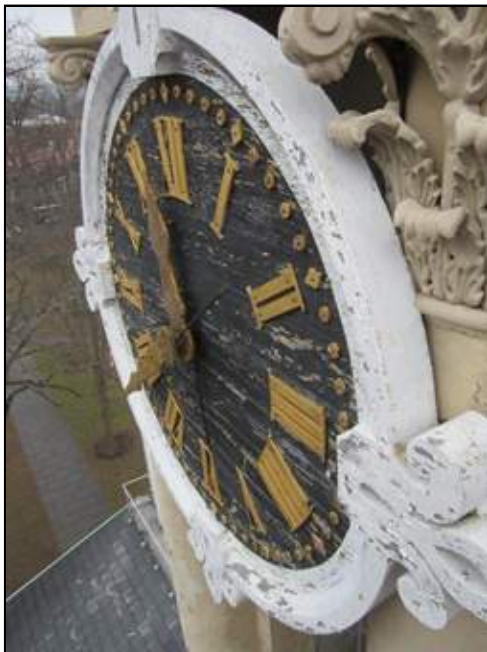
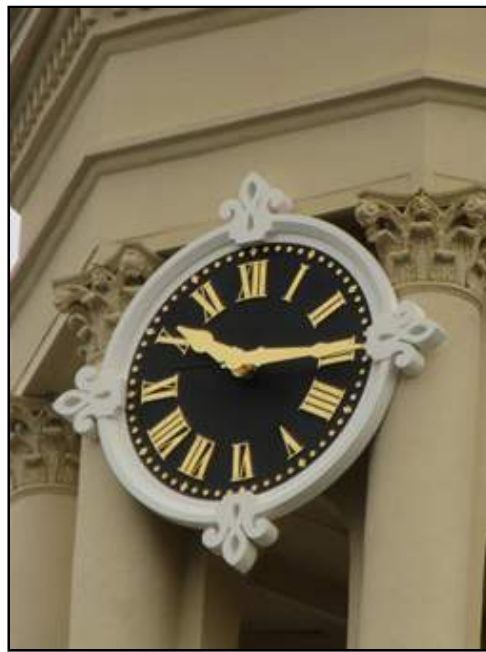
Existing and refurbished clock.
