DVASE 2022 Excellence in Structural Engineering Awards Program

Approximate construction cost of facility submitted:	\$37.3M
Name of Project:	Franklin Field - Grandstand Restoration Phases 2 to 6
Location of Project:	233 S. 33rd St. Philadelphia, PA
Date construction was completed (M/Y):	01/2022
Structural Design Firm:	CVM Engineers Inc. 1002 W. 9th Ave. King of Prussia, PA 19406
Affiliation:	All entries must be submitted by DVASE member firms or members.
Construction Manager:	JJ White, Inc. 5500 Bingham St. Philadelphia, PA 19120
Concrete Contractor:	Pullman, SST 227 High Hill Rd. Swedesboro, NJ 08085

Franklin Field – Restoring America’s First Modern Football Stadium

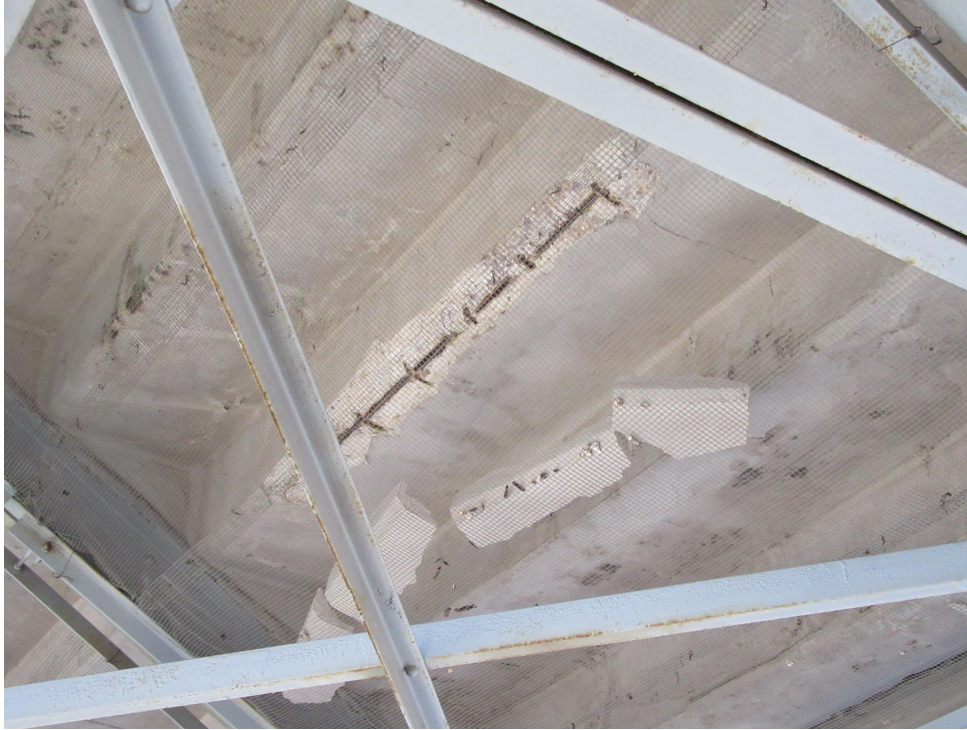
Figure 3. Concrete spall captured on netting.

Extensive repairs were required to address concrete spalling due to reinforcing steel corrosion, with most of repairs located at or adjacent to previous repairs. The repairs were largely designed to be full depth, with the repair material selected to match the original concrete properties. Access limitations at the stadium resulted in all repairs being completed using pre-packaged concrete materials, placed by hand using 5-gallons buckets.

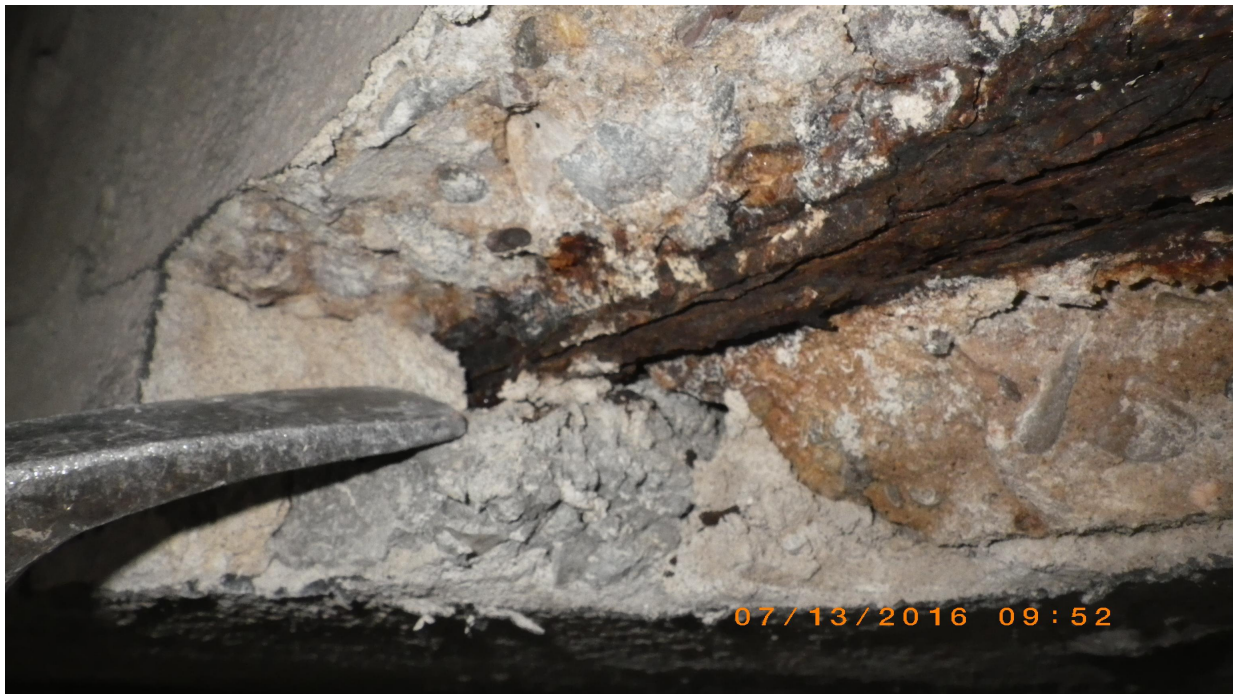
Figure 4. Concrete spall at prior repair. Note presence of multiple repair materials and lack of reinforcing steel undercutting.

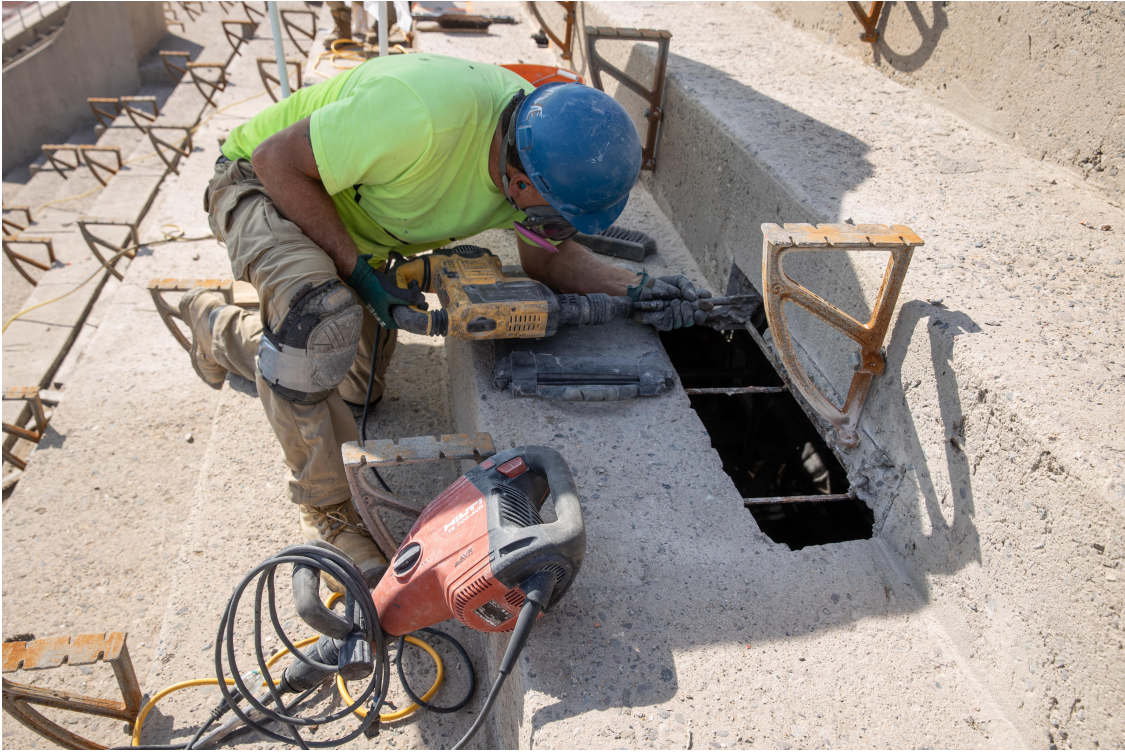
Figure 5. Full depth repair being completed.

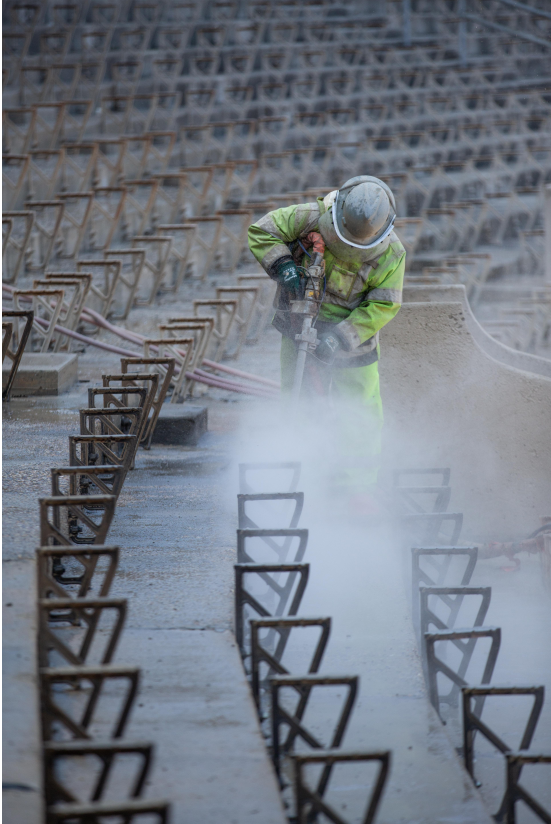
Figure 6. Existing coating removal via hydrodemolition.

Several approaches were considered to protect the existing reinforcing steel and mitigate the potential for future corrosion damage. The primary mechanism was the application of a urethane-based waterproof membrane on the grandstand surfaces after removal of the failed coatings using hydro-demolition. Sacrificial galvanic anodes were selected as a secondary mechanism to protect the reinforcing steel as they satisfied the owner’s need for a minimal maintenance system. Installed in both the repaired and unrepaired grandstand areas, the anode size and spacing was selected to provide corrosion protection for the 25-year design service-life. To monitor the performance of the repairs, a corrosion monitoring system was installed in the grandstand sections. The system allows for monitoring of both internal and external temperature and relative humidity of the concrete grandstands and the current generated by the sacrificial anodes. Monitoring results will be used by the Owner to plan future maintenance.

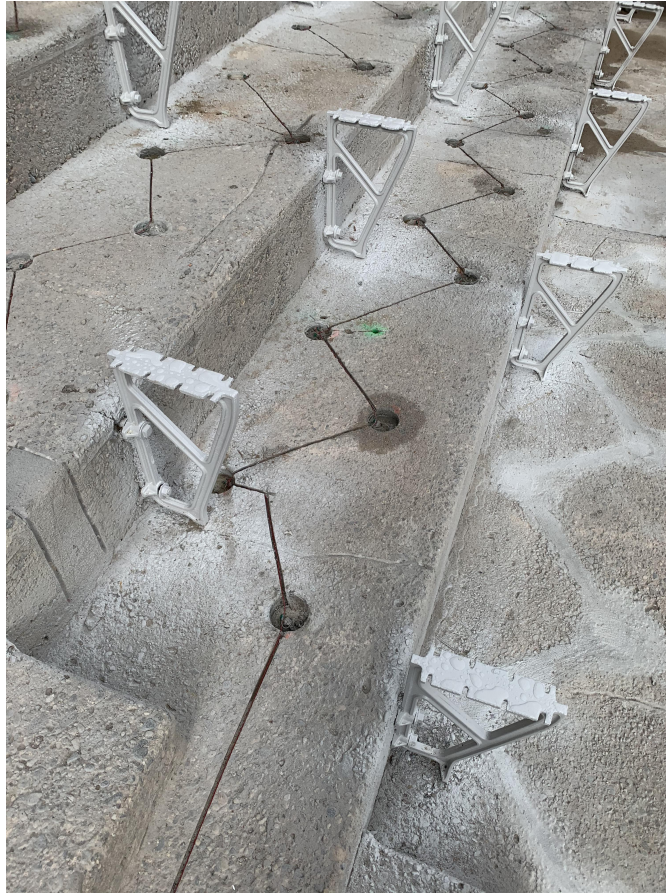
Figure 7. Anode installation.

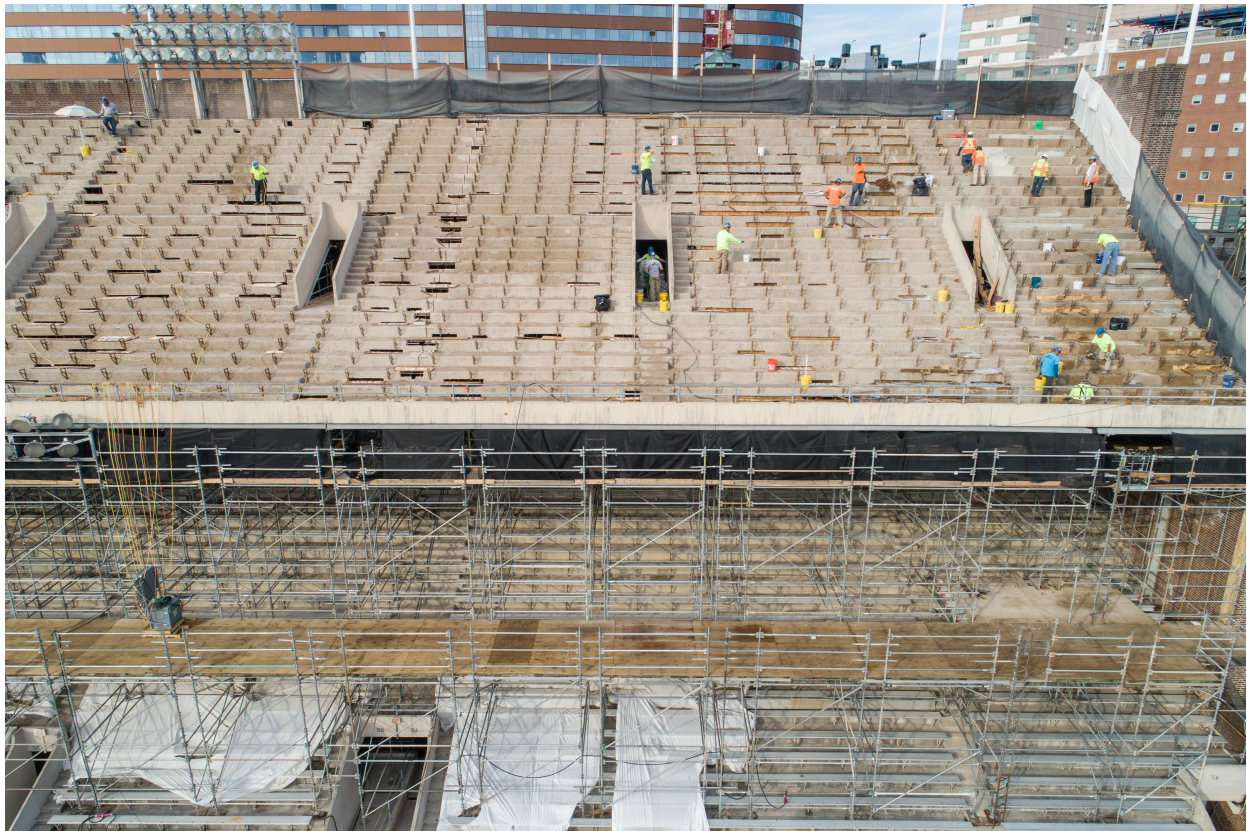
Figure 8. Repairs in process upper south grandstands.
